NASA CR-165237
R89AEG458

PROGRAM TO DEVELOP SPRAYED, PLASTICALLY DEFORMABLE COMPRESSOR SHROUD SEAL MATERIALS

FINAL REPORT
JUNE 29, 1976 - SEPTEMBER 29, 1980

BY
J.D. SCHELL and R.C. SCHWAB
MATERIALS AND PROCESS TECHNOLOGY LABORATORIES
AIRCRAFT ENGINE GROUP
GENERAL ELECTRIC COMPANY
CINCINNATI, OHIO 45215

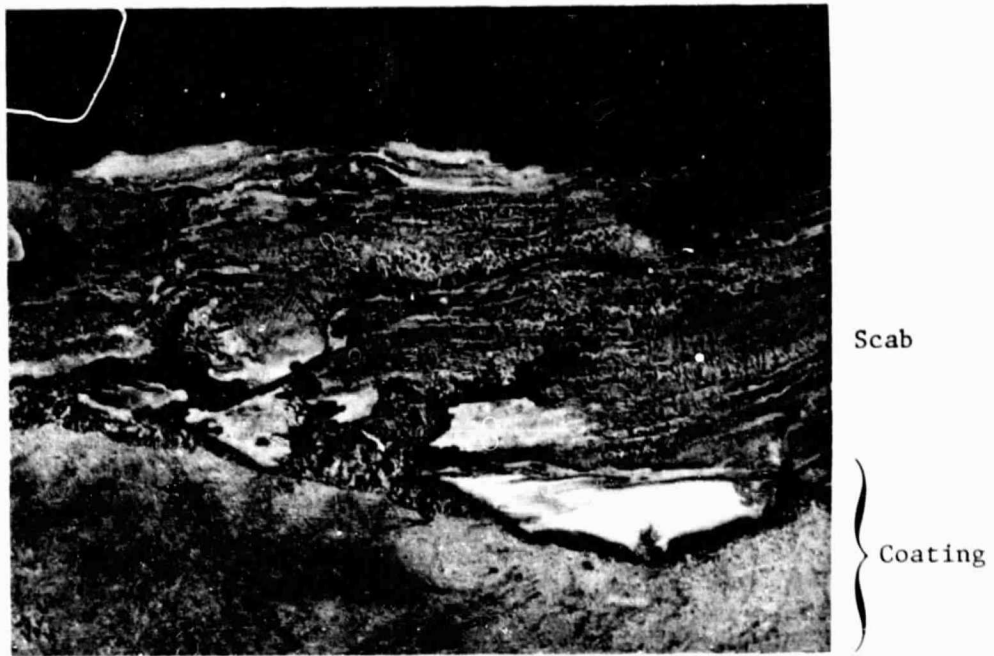
Figure 7. Microstructure of Cu Coating (Hot Rub) in a Scabbed Area Showing the Variety of Phases Present. 100X

6. Reactions between the transferred blade metal and the coating were evident in the variety of phases present in the microstructure of the scabbed area (Figure 7). The reaction zones of Cu-5Al and Cu-9Al coatings were primarily at the edges and corner of the rub paths where scabbing usually initiated. Microprobe analysis normal to the surface and under the rub paths indicated that the phases ranged in composition from pure coating to pure blade metal. The Cu/Ti ratios in the intermediate regions were similar to that of the Cu-Ti eutectic. Exact phase identification was not attempted because the coating/blade-metal mixtures were quaternary alloys with unknown phase diagrams.

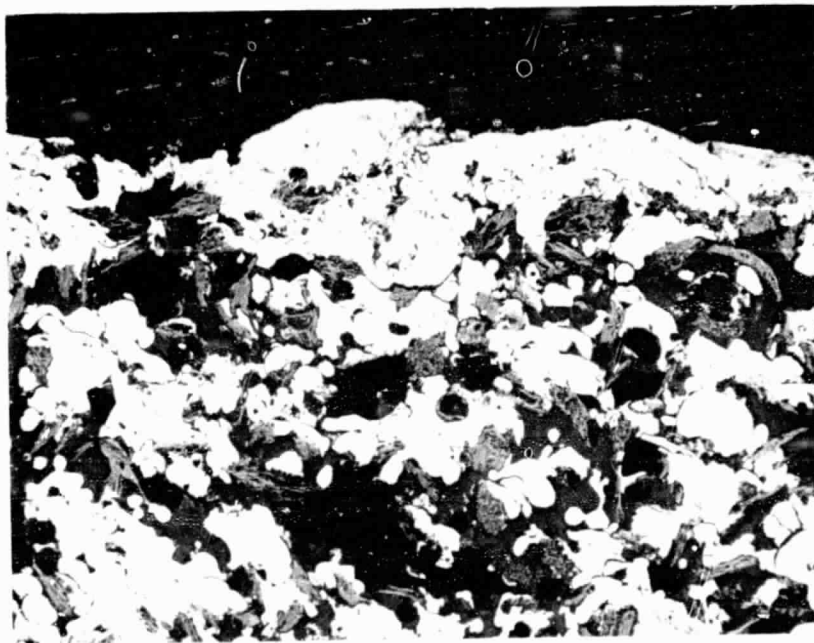
a. Cold Rub, 311 K (100° F)

b. Hot Rub, 756 K (900° F)

Figure 14. Cross Sections of Rub Paths Showing
Compaction of AlBr/NiCg. 100X

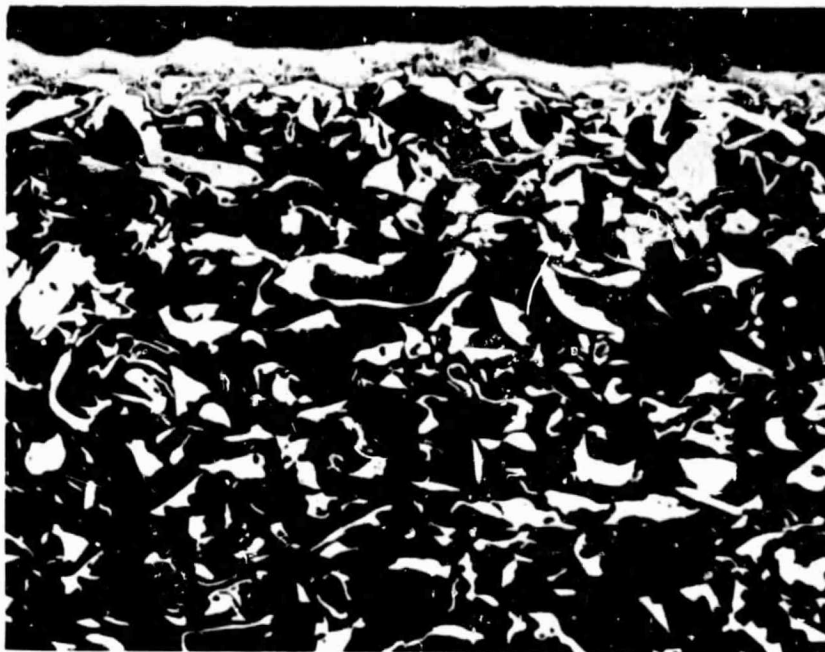
a. Al/Feltmetal Cold Rub, 311 K (100° F)

b. AlBr/Feltmetal Hot Rub, 756 K (900° F)

Figure 18. Cross Sections of Rub Paths from Metal-Spray/Feltmetal Materials. 100X

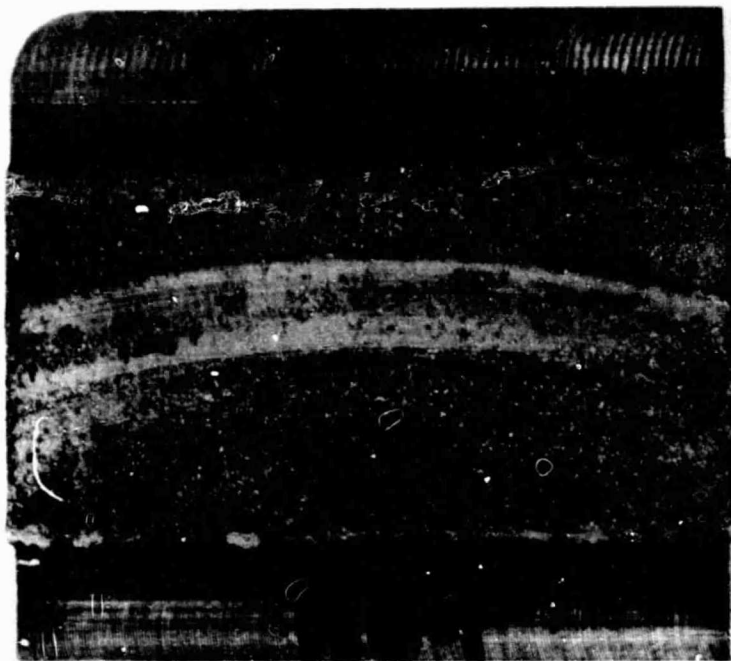
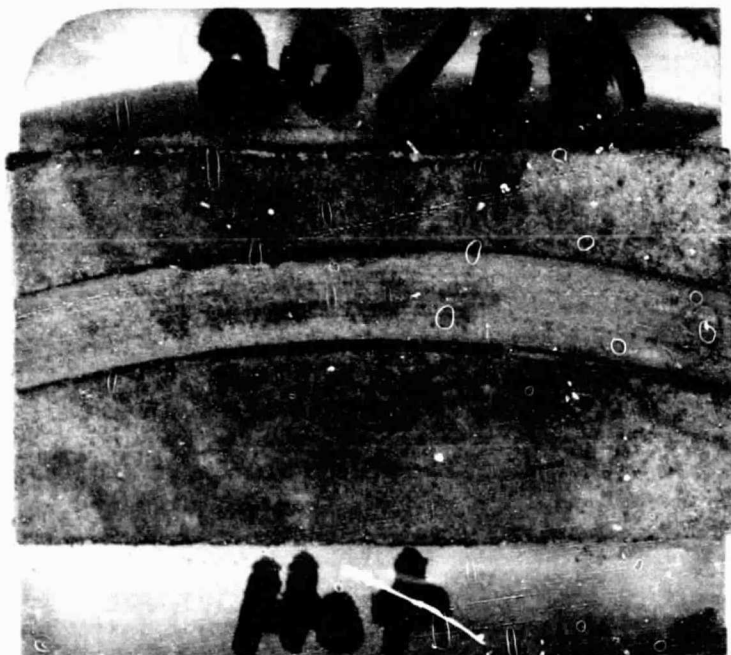
Figure 20. The Hot-Rub Surfaces of the Cu-9Al + 20% Ekonol. 2X

1. Significant substrate temperature rises occur only when measurable blade wear or pick-up occurs (this generalization is complicated by the low thermal conductivity of Feltmetal).
2. Significant substrate temperature rise rates occur only for Cu-9Al + 20% Ekonol specimens.
3. The highest rub forces are associated with either blade wear or pick-up.
4. The presence of a Feltmetal underlayer does not cause a significant reduction in rub forces in relation to the spray-coating materials.
5. Cu-9Al + 20% Ekonol spray coatings with and without the Feltmetal underlayer yielded partially or completely smooth, smeared, rub surfaces, $\approx 3.81 \mu\text{m}$ (150 μin) rms, after 755 K (900° F) rubs (Figure 20).

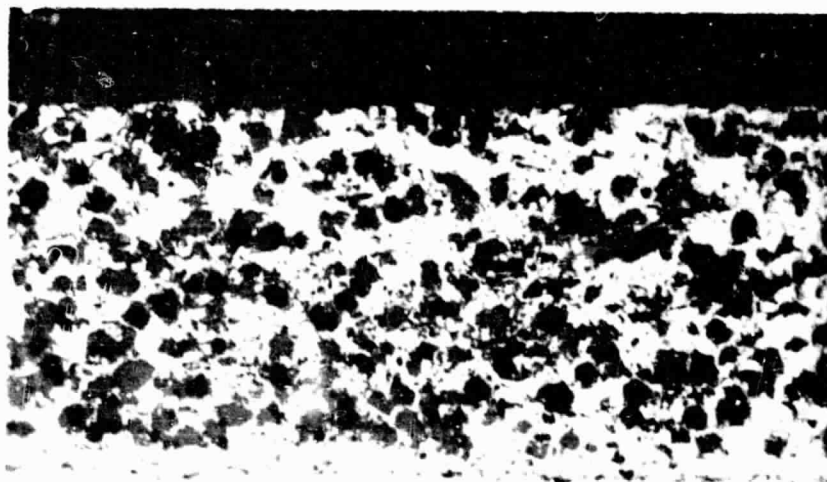
b. Away from Rub Path

Figure 21. Cross Sections of Cu-9Al + 20%
Ekonol Coating. 50X

1. Cu-9Al + 20% Ekonol and Cu-9Al + 40% Ekonol coatings with or without the Feltmetal underlayer have not been compacted under the rub paths (Figure 21).
2. Coatings with the Feltmetal underlayer were not pushed into the felt during rubs.
3. In smooth, rubbed areas there is only a thin layer of smeared material. At very high magnification, there appear to be some small Cu-Ti eutectic zones in the smeared areas.
4. Substantial amounts of Ekonol have been lost from hot-rub specimens and from areas adjacent to the rub paths of cold-rub specimens with Feltmetal underlayers.

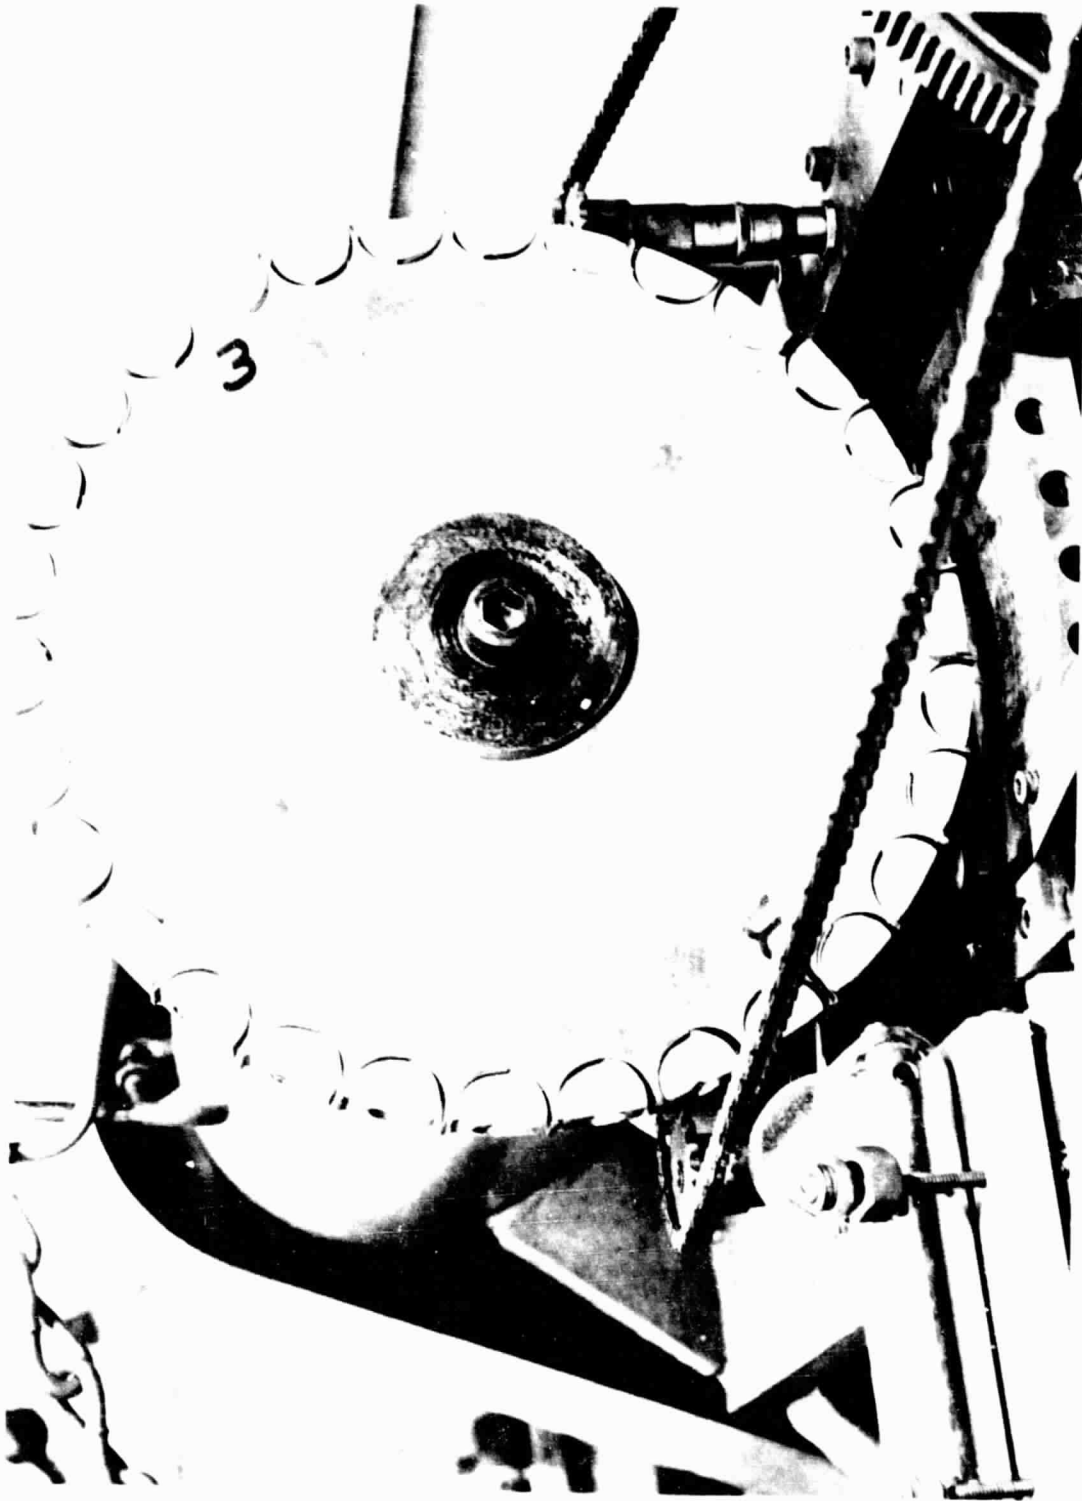
Figure 27. Abradability Tester.

versus 152 m/sec (750 versus 500 ft/sec) but was limited to room-temperature rub testing. The abradable material was sprayed on curved rub panels matched to the blade tip radius of a rotating wheel holding up to 30 blades. During the test, after the desired rotational speed of the wheel has been attained, the platform is slowly raised to allow incursion of the blades into the abradable material. This rate of incursion can be varied from 2.54 to 254 $\mu\text{m}/\text{sec}$ (0.1 to 10 mils/second) and approximates most of the rotor/stator incursion rates experienced in a typical engine. For Task III, incursion rates of 2.54, 25.4, and 254 $\mu\text{m}/\text{sec}$ (0.1, 1.0, and 10 mil/sec) were used with six blades in the wheel. The duration of the test is usually controlled to give a 381 to 508 μm (15 to 20 mil) total incursion of blades into the seal material [e.g., 15 to 20 seconds at 25.4 $\mu\text{m}/\text{sec}$ (1.0 mil/sec)].

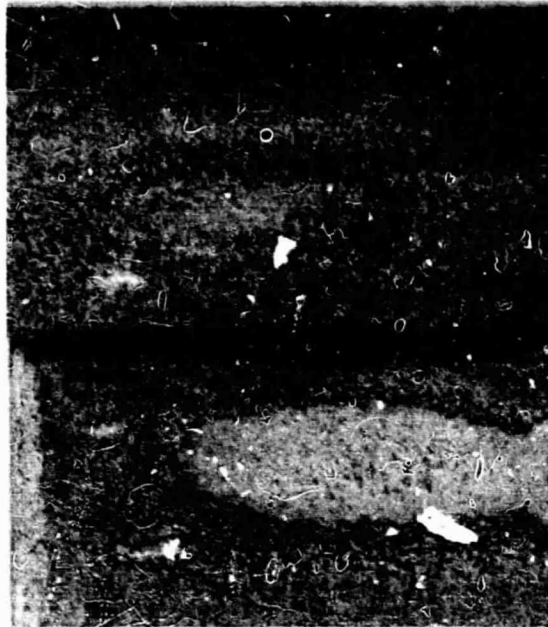
Figure 31. Erosion Samples of AlBr + 20% Ekonol.

The Lynn (elevated temperature) rub-test results are summarized in Table XVII. No blade wear occurred for either Ti-6Al-4V or Inconel 718 blades under the test conditions investigated. These rub panels (Figure 31) also exhibited the layered material-pullout effect seen in the room-temperature rub tests. Rub-force measurements were included in the Lynn tests. Measurable shear forces of 1.8 to 3.1 N (0.4 to 0.7 lbf) were observed for all the 254 $\mu\text{m}/\text{sec}$ (0.01 in./sec) incursions into rub panels, with and without Feltmetal 515B underlayer, but no measurable shear forces occurred during rubs at the 25.4 and 2.54 $\mu\text{m}/\text{sec}$ (0.001 and 0.0001 in./sec) incursion rate. It must be assumed that the shear forces are related to the higher volume of material removed during a single blade encounter (i.e., greater bite per blade) since no evidence for differences in coating compaction or frictional heating was observed between the high incursion rate and the two lower incursion rates.

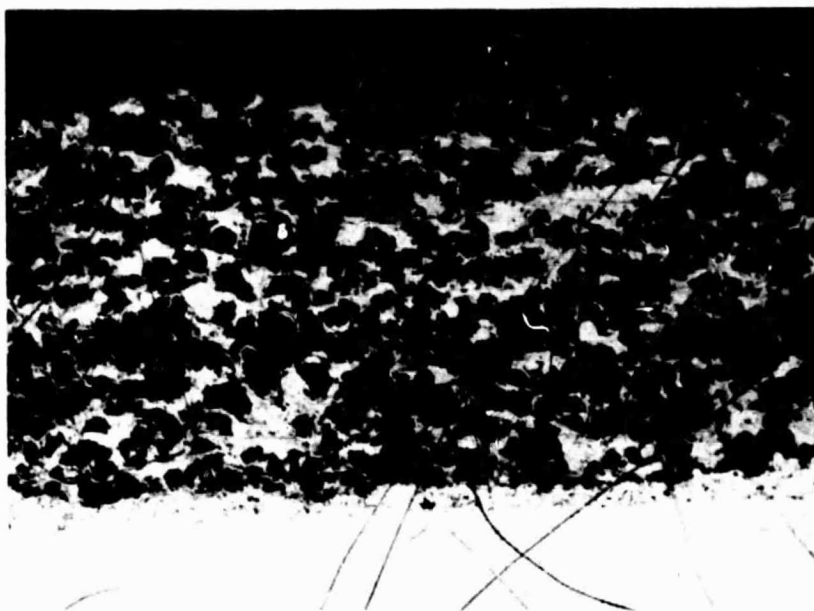
Figure 35. Preliminary, Hand-Sprayed, Second-Iteration AlBr + 20% Ekonol Showing a More Homogeneous Microstructure. 50X

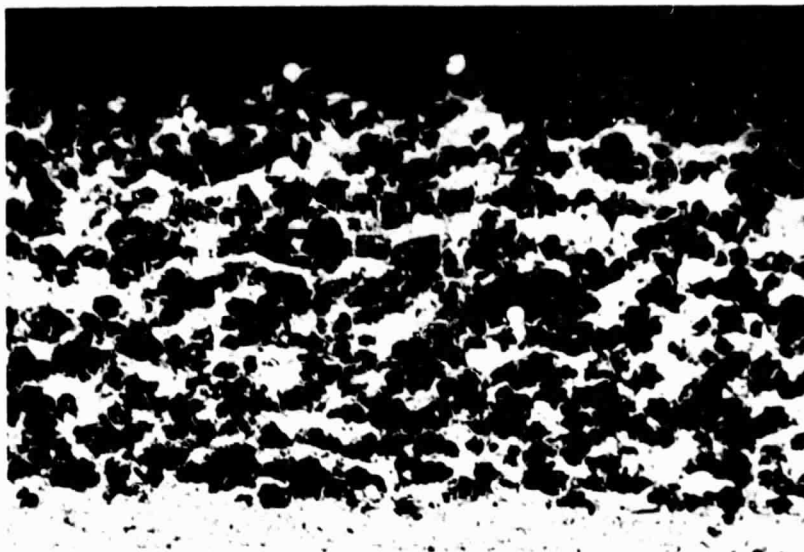
a. As-Sprayed; Well-Distributed Ekonol Phase

b. Preexposed at 755 K (900° F)/50 Hours;
Complete Ekonol Burnout

Figure 36. AlBr + 15% Ekonol Coatings.

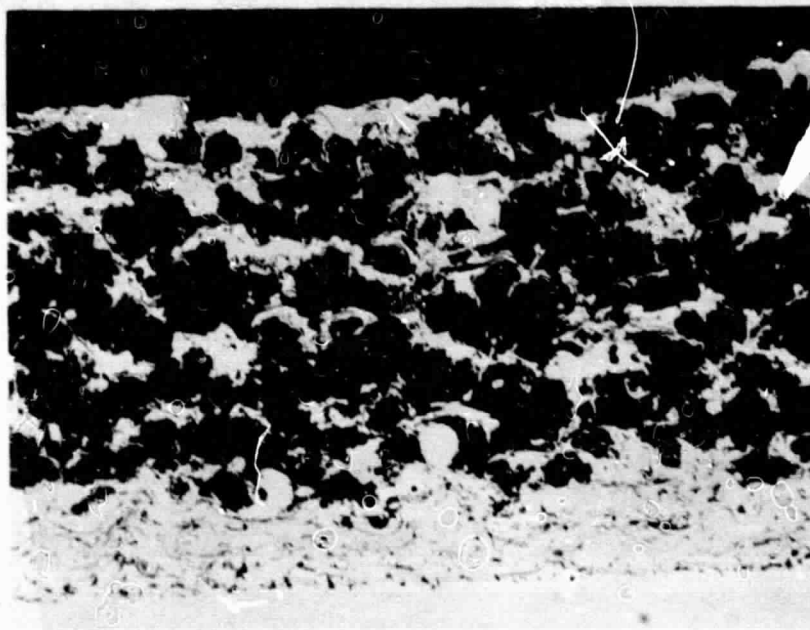
Figure 40. AlBr + 15% Ekonol Room-Temperature-Rub Panels.

a. As Sprayed

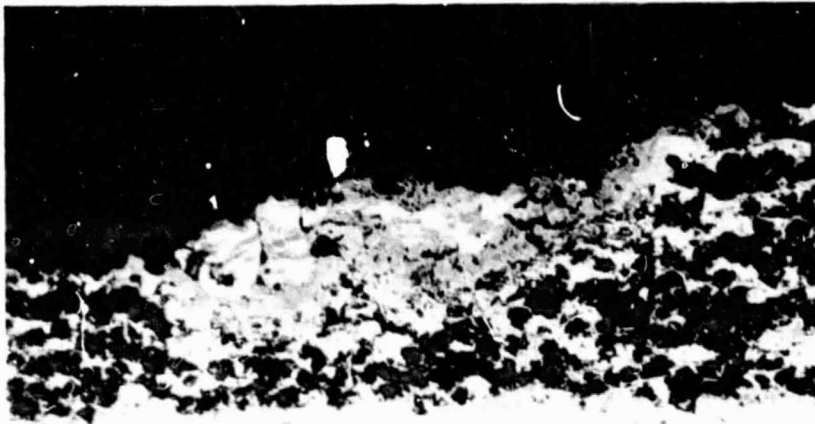
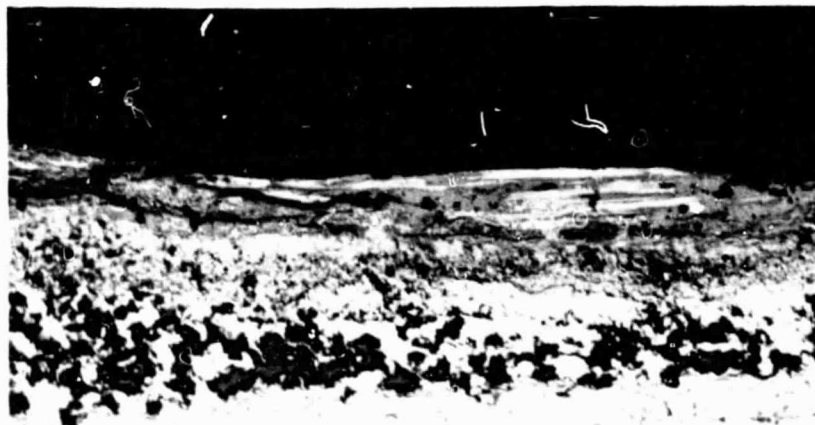
a. Transverse Section Under Rub

b. Longitudinal Section Under Rub

} Scabbing

Figure 46. Elevated-Temperature Rubs on AlBr + 15%
Ekonol with Ti-6Al-4V Blades at 25.4
 $\mu\text{m}/\text{sec}$ (0.001 in./sec) Incursion Rate. 50X

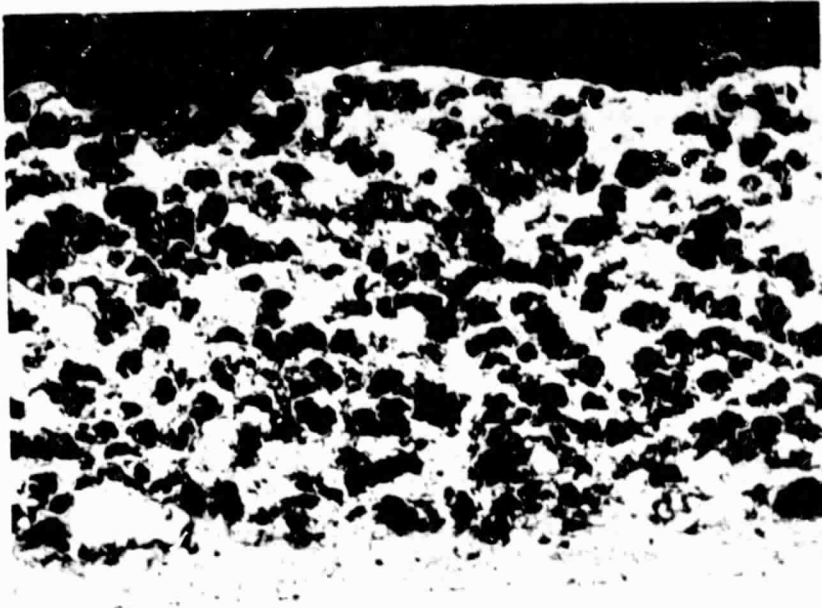
Figure 48. Preliminary, Third-Iteration, Spray-Coating Microstructures.

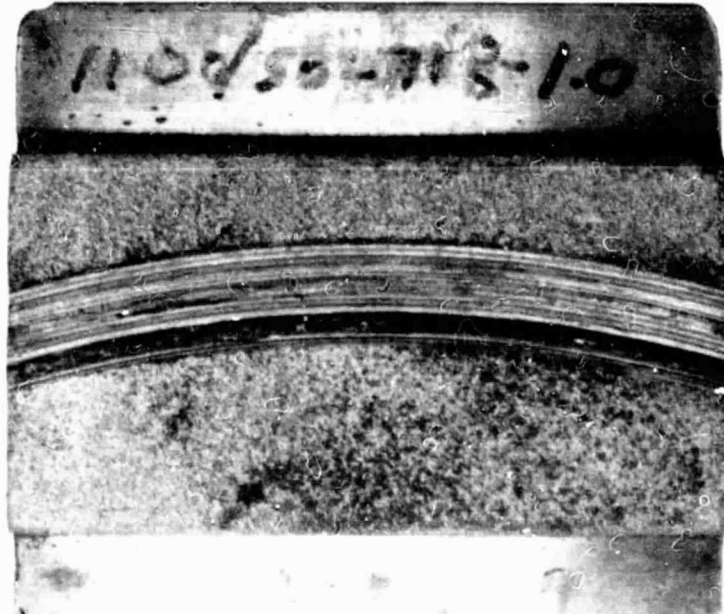
b. Preexposed 867 K (1100° F)/50 Hours

Figure 56. AlBr + 10% Ekonol Rub Panels from 867 K (1100° F) Test with Inco 718 Blades, 25.4 $\mu\text{m}/\text{sec}$ (0.001 in./sec) Incursion Rate. 2X

The Lynn elevated-temperature rub-test data are summarized in Table XXV, and the rub panels have been included in figure 50. The Inconel 718 blade rubs at 867 K (1100° F) (Figure 56) were unworn over most of the blade tips except for some localized notching in rubs against the preexposed [867 K (1100° F)/50 hr] rub panels. Typical features of the Inconel 718 blades from these rubs are shown in Figure 57. An aluminum bronze pickup layer on one of the unworn blades was evident for the unetched blade (top photo). The same area did not show a heat-affected zone (middle photo) after etching. Most of the transferred aluminum bronze was removed by the acid etch (100 cm³ methanol, 80 cm³ HCl, 40 cm³ acetic acid, 10 cm³ HF, and 10 cm³ CuCl₂). A transverse section (i.e., perpendicular to the rub direction) through one of the Inconel 718 blade tips rubbed against the preexposed aluminum bronze rub liner showed localized notching up to 0.2 mm (0.008 in.) deep (bottom photo) and located near the blade corner. The preexposed rub panel exhibited complementary deep-groove formation at the rub-path edge. No groove formation like this was seen on the earlier AlBr/15% Ekonol preexposed coating.

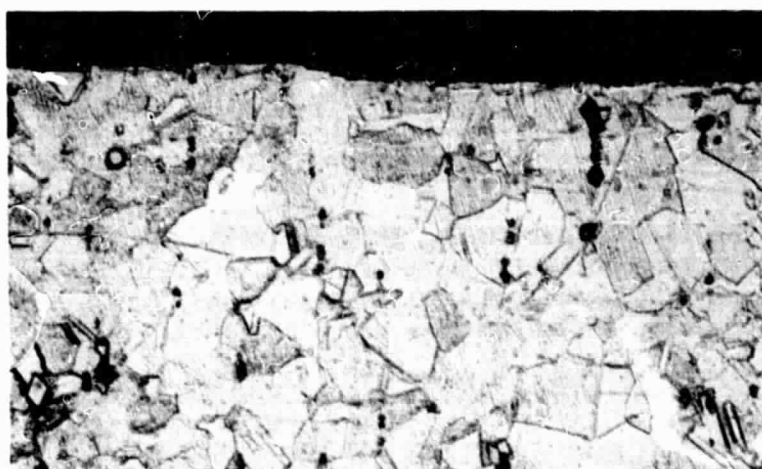
- b. No Noticable
Heat-Affected
Zone Was Seen
After Etching
400X

- c. Transverse Section
Showing Localized
Grooves up to
0.203 mm (0.008 in.)
Usually Occuring
Near the Blade
Corner Where Heat-
Transfer Conditions
Were Different
50X

Figure 57. Inco 718 Blades from 867 K (1100° F) Rub Tests.

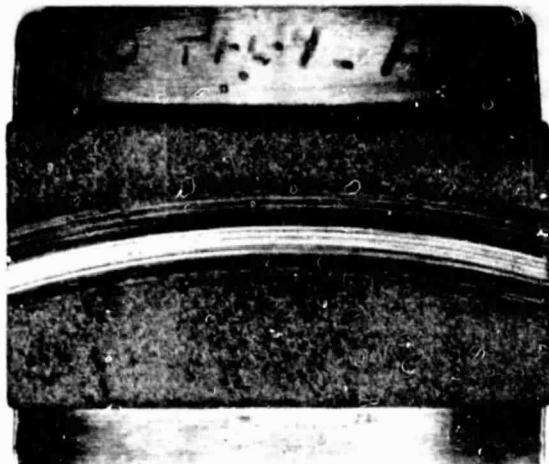
- b. As-Sprayed, $25.4 \mu\text{m}/\text{sec}$
(0.001 in./sec) Incursion Rate

The $25.4 \mu\text{m}/\text{sec}$ (0.001 in./sec) rub was fairly smooth with some grooving, but the $2.54 \mu\text{m}/\text{sec}$ (0.0001 in./sec) rub was rougher due to more scabbing.

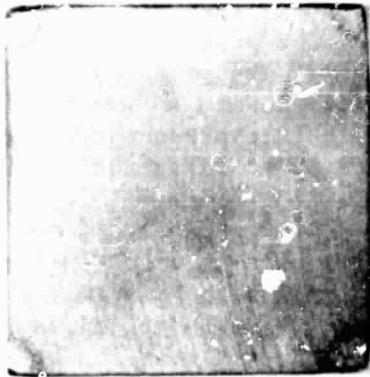
a. As-Sprayed, 0.53-1.52 μm
(21-60 μin) AA

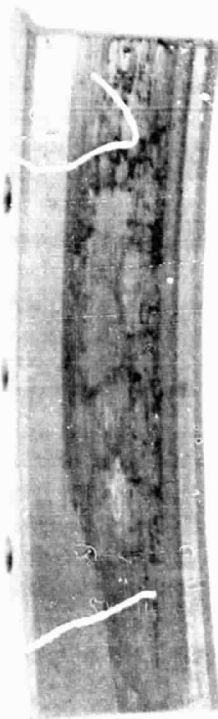
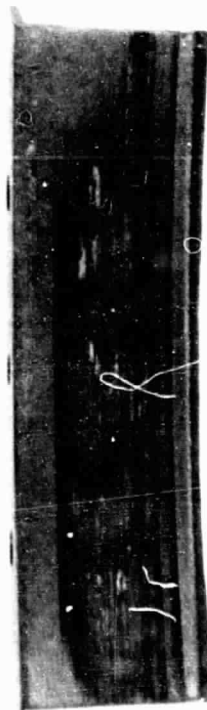
- b. Preexposed at 755 K (900° F)/50 Hours,
Versus Inco 718 Blades,
2.54 $\mu\text{m}/\text{sec}$ (0.0001 in./sec) Incursion Rate

- c. Preexposed at 755 K (900° F)/50 Hours,
Versus Inco 718 Blades,
25.4 $\mu\text{m}/\text{sec}$ (0.001 in./sec) Incursion Rate

- d. Preexposed at 755 K (900° F)/50 Hours,
Versus Ti-6Al-4V Blades,
25.4 $\mu\text{m}/\text{sec}$ (0.001 in./sec) Incursion Rate

Figure 67. AlBr + 12.5% Ekonol 755 K (900° F) Rubs.

Four tests were conducted under the above conditions. Figures 67 and 68 show the tested rub liners and detailed features of the rub paths; Figures 69 through 72 show typical blades from each test. In the first test, the as-sprayed coating was rubbed by Inconel 718 blades at the 24.8 $\mu\text{m}/\text{sec}$ (0.001 in./sec) incursion rate. Blade wear was high, 0.41 to 0.58 mm (0.016 to 0.023 in.), and most severe on the forward blade corner. (The blade tips are inclined relative to the axis of rotation and so that one corner of the blade passes a reference point on the rub liner before the other passes the same reference point.) There was a large amount of transferred aluminum bronze on the leading edge, and Tempil Laq on the back side of the case liners indicated temperatures during the rub were 867 and 922 K (1100° and 1200° F).

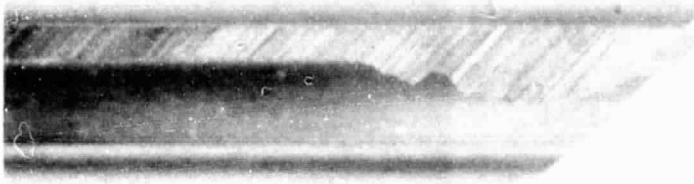
a. Looking Down on Tip

Figure 69. Blades from AlBr + 12.5% Ekonol As-Sprayed
Vs. Inco 718 Blades, 25.4 $\mu\text{m}/\text{sec}$ (0.001
in./sec) Incursion Rate. 4X

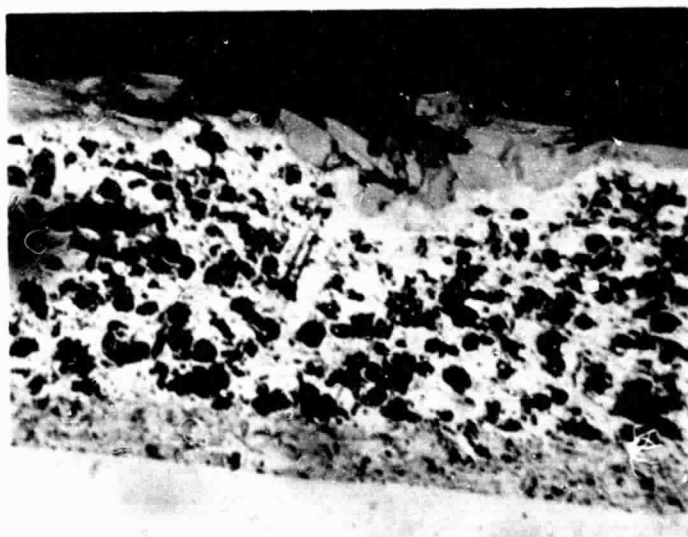
a. Compacted Surface Layer with Pullout Area

b. Scab Formation Has Apparently Been Pushed Into Porous Coating and Caused Additional Compacting

Figure 76. AlBr + 12.5% Ekonol Rub Liner from the 755 K (900° F), 298 m/sec (1200 ft/sec) Tip Speed Test with Titanium Blades at the 2.54 μ m/sec (0.001 in./sec) Incursion Rate. 50X
